MEMORANDUM	FOR:	Chief, Manufacturing and Services Division, ORR
ATTENTION	:	25X1A
THROUGH	:	Chief, Requirements Branch, Reconnaissance Group, CG
FROM	:	Chief, CIA/PID (NPIC)
SUBJECT	:	Rail Facilities at Tien-ching (Tientsin), China
REFERENCE	:	(1) ORR Requirement No. C-RR3-80,539° (2) CIA/BID Project@No. C 1246/63

RAIL FACILITIES IN TIENTSIN, CHINA LOCOMOTIVE REPAIR BUILDINGS

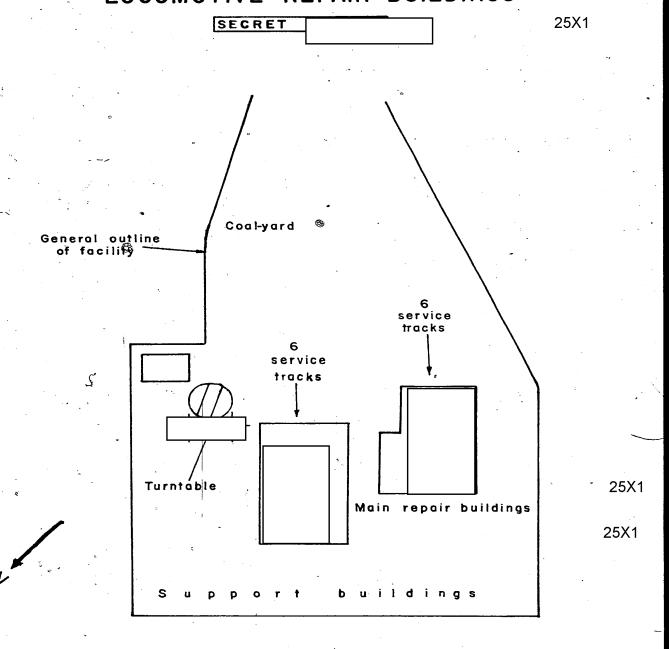
CIA/PID/IB- P-642/63

- 4. Included with this memorandum is a diagrammatic sketch of the locomotive repair facility (Enclosure No. 2) located in area 1. All necessary information is annotated on this sketch.
